**Boeing Plant 2
Seattle, Washington**

Phase II Transformer PCB Investigation Report

August 3, 2005

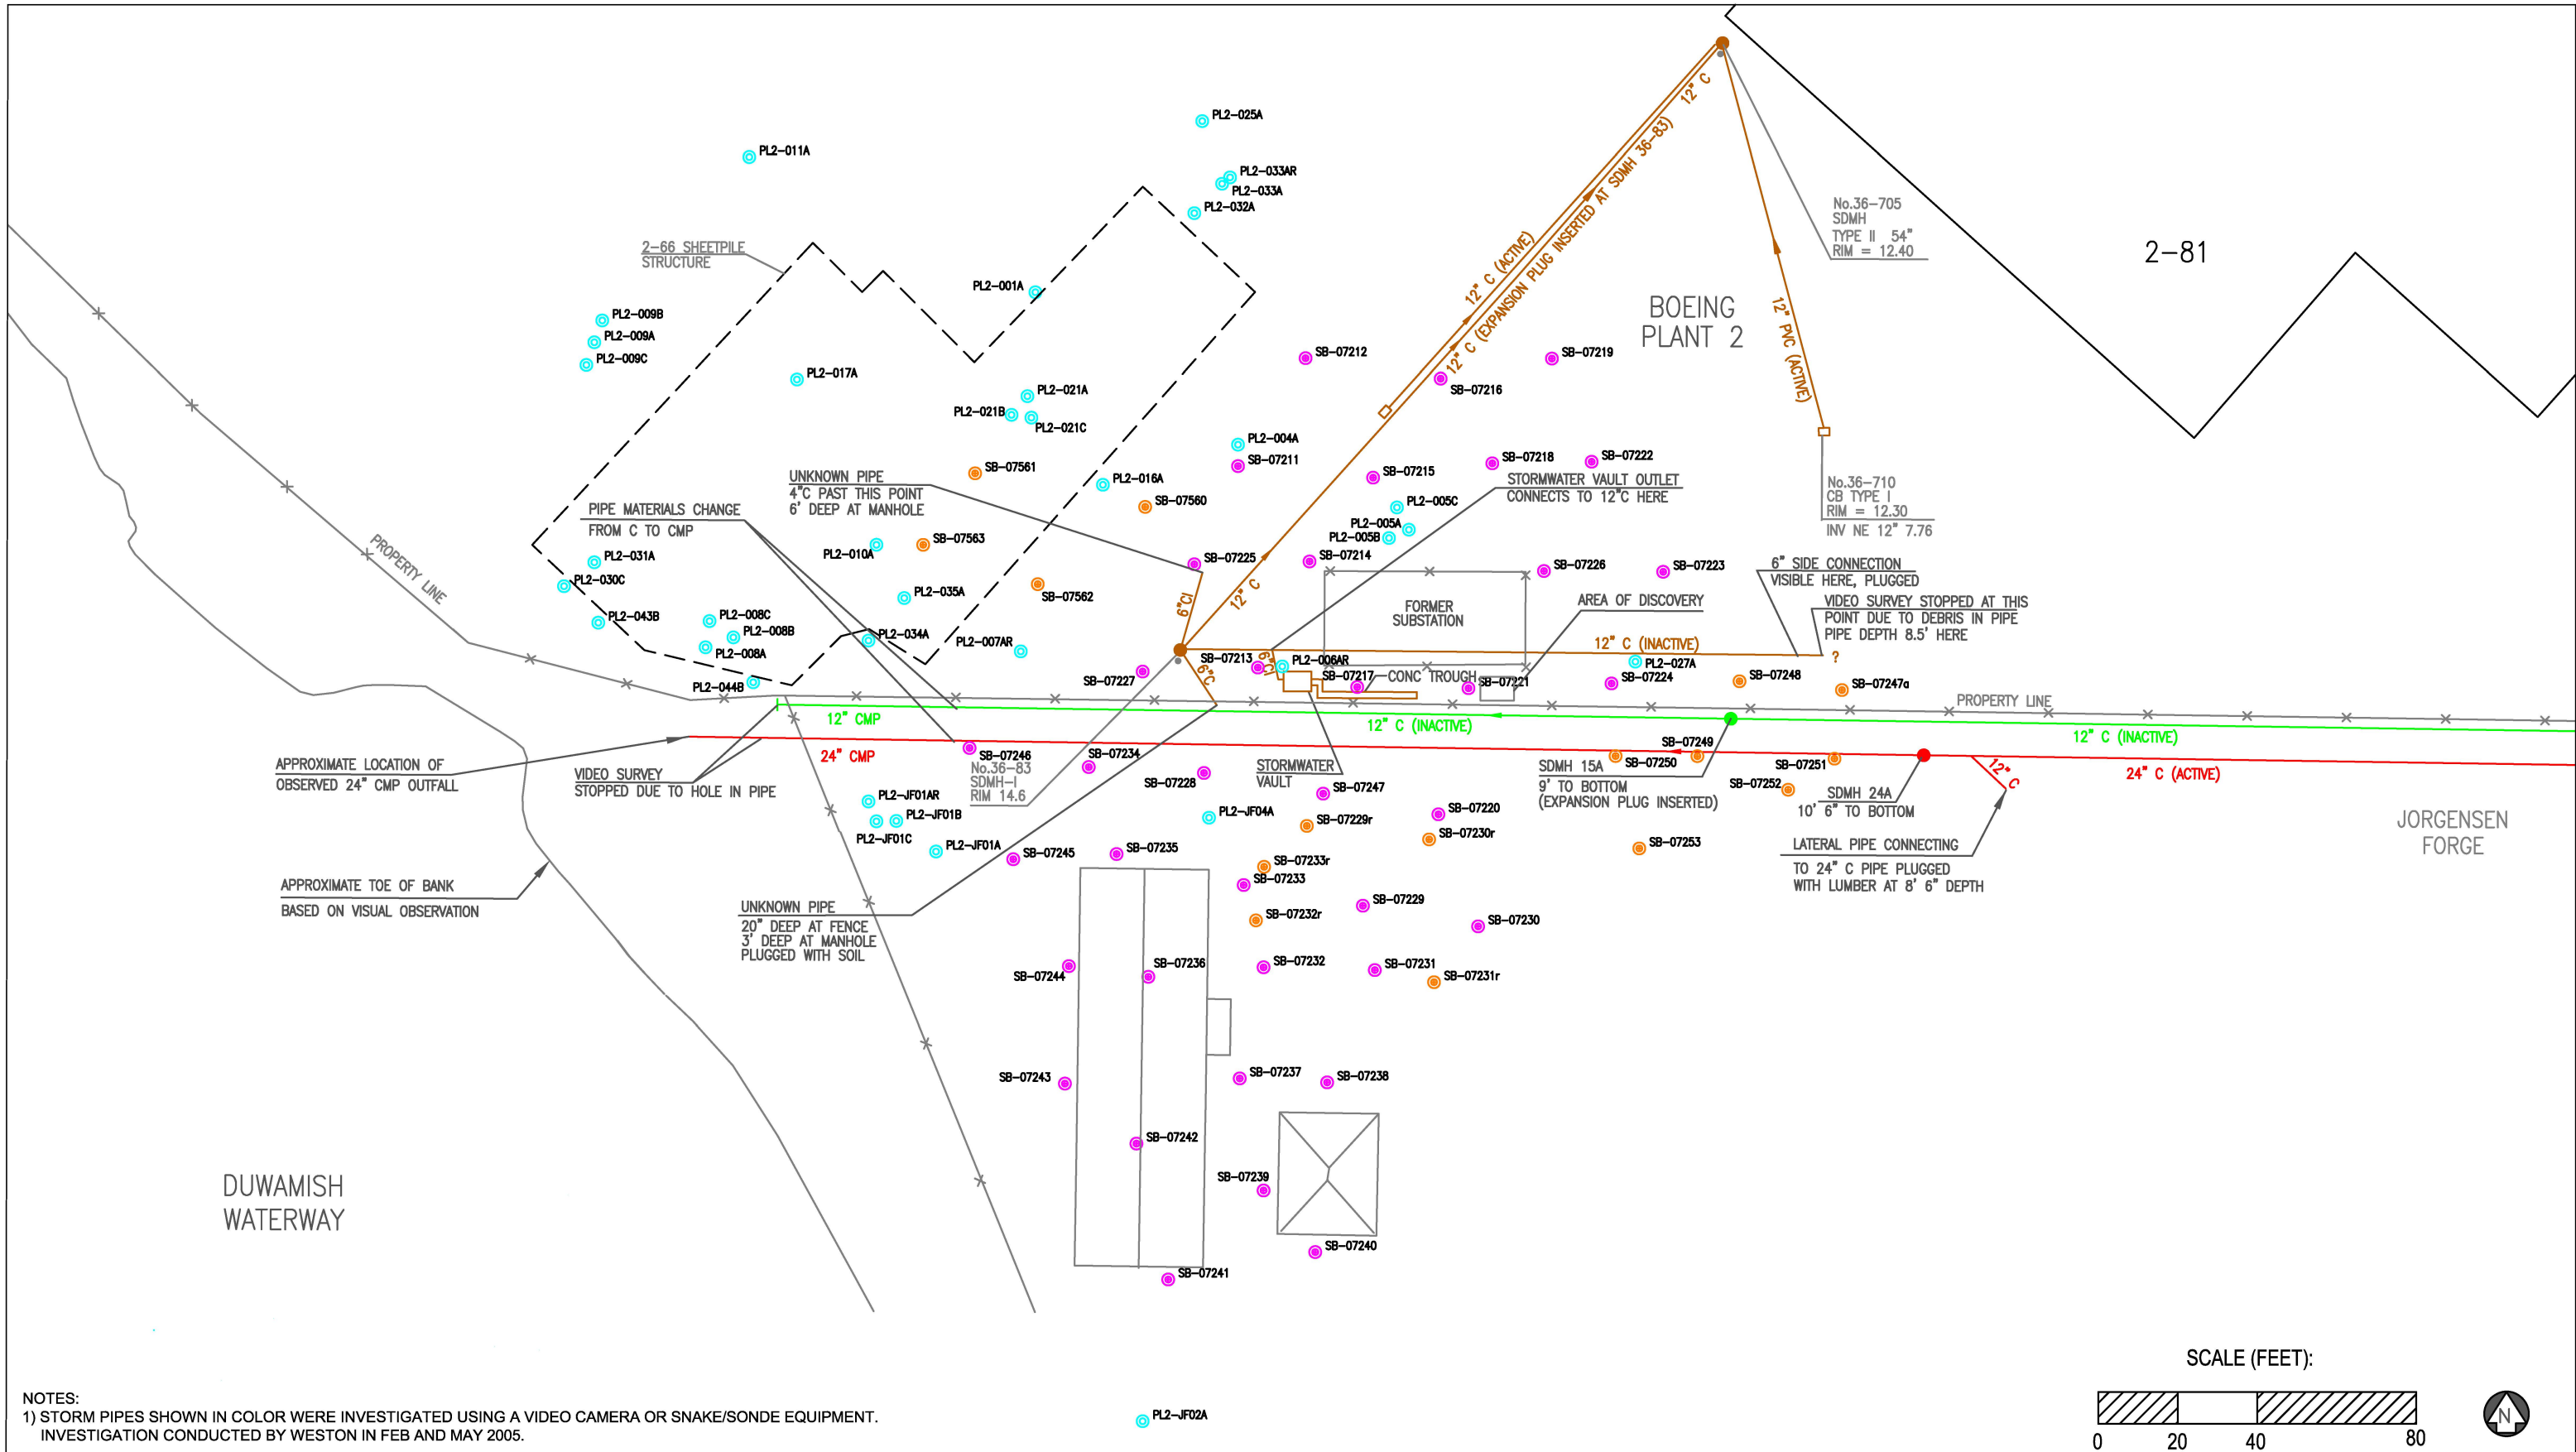
NOTES:
1) STORM PIPES SHOWN IN COLOR WERE INVESTIGATED USING A VIDEO CAMERA OR SNAKE/SONDE EQUIPMENT.
INVESTIGATION CONDUCTED BY WESTON IN FEB AND MAY 2005.

The purpose of the storm system survey was to determine the alignment and condition of existing pipes and to identify any unknown connecting pipes. Prior to the Phase II survey, the alignment, integrity, and connections of various components of the storm system could not be firmly established. Therefore, the potential existed for PCBs in soil or groundwater to enter the storm system through cracks and joints and become redistributed within the solids of the system, thereby making these pipes a possible active pathway for the migration of PCBs from the substation area to the waterway.

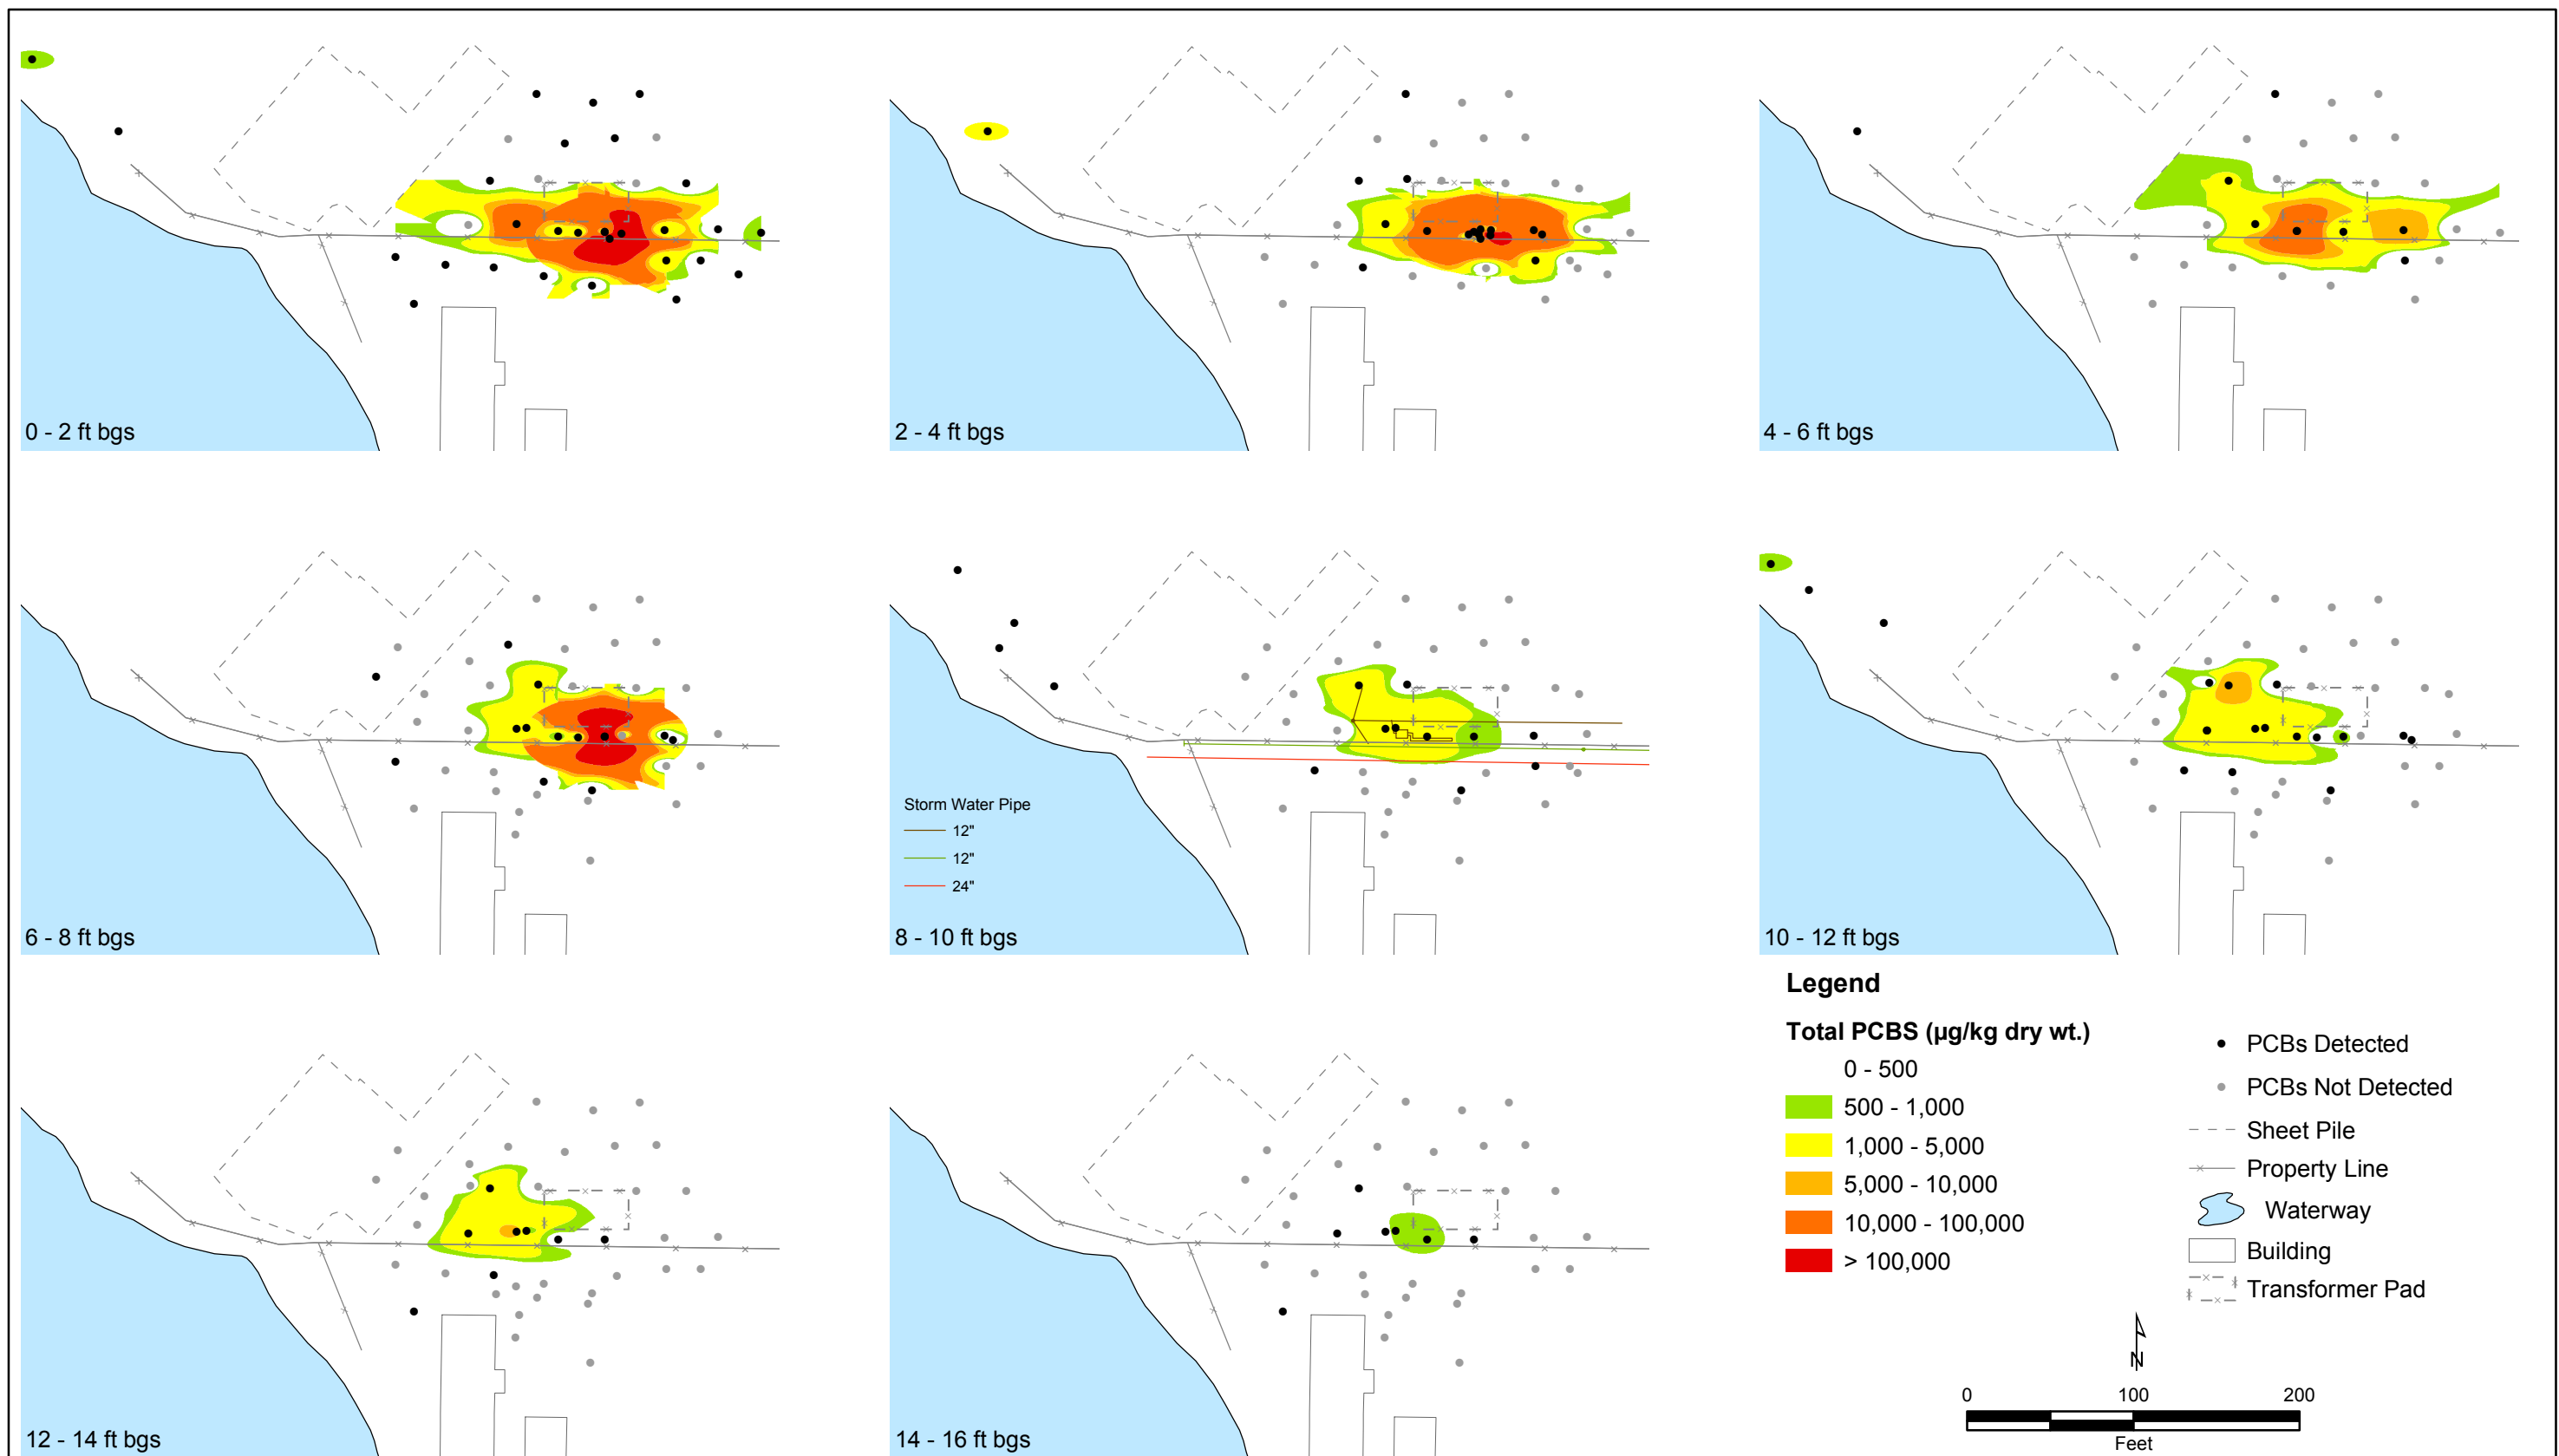
Figure 3.3
 Isoconcentration Contours of Total PCBs in Soil
 - Variation with Depth

NOTE: Includes RFI, SW Bank, Area of Discovery, Phase I and Phase II data

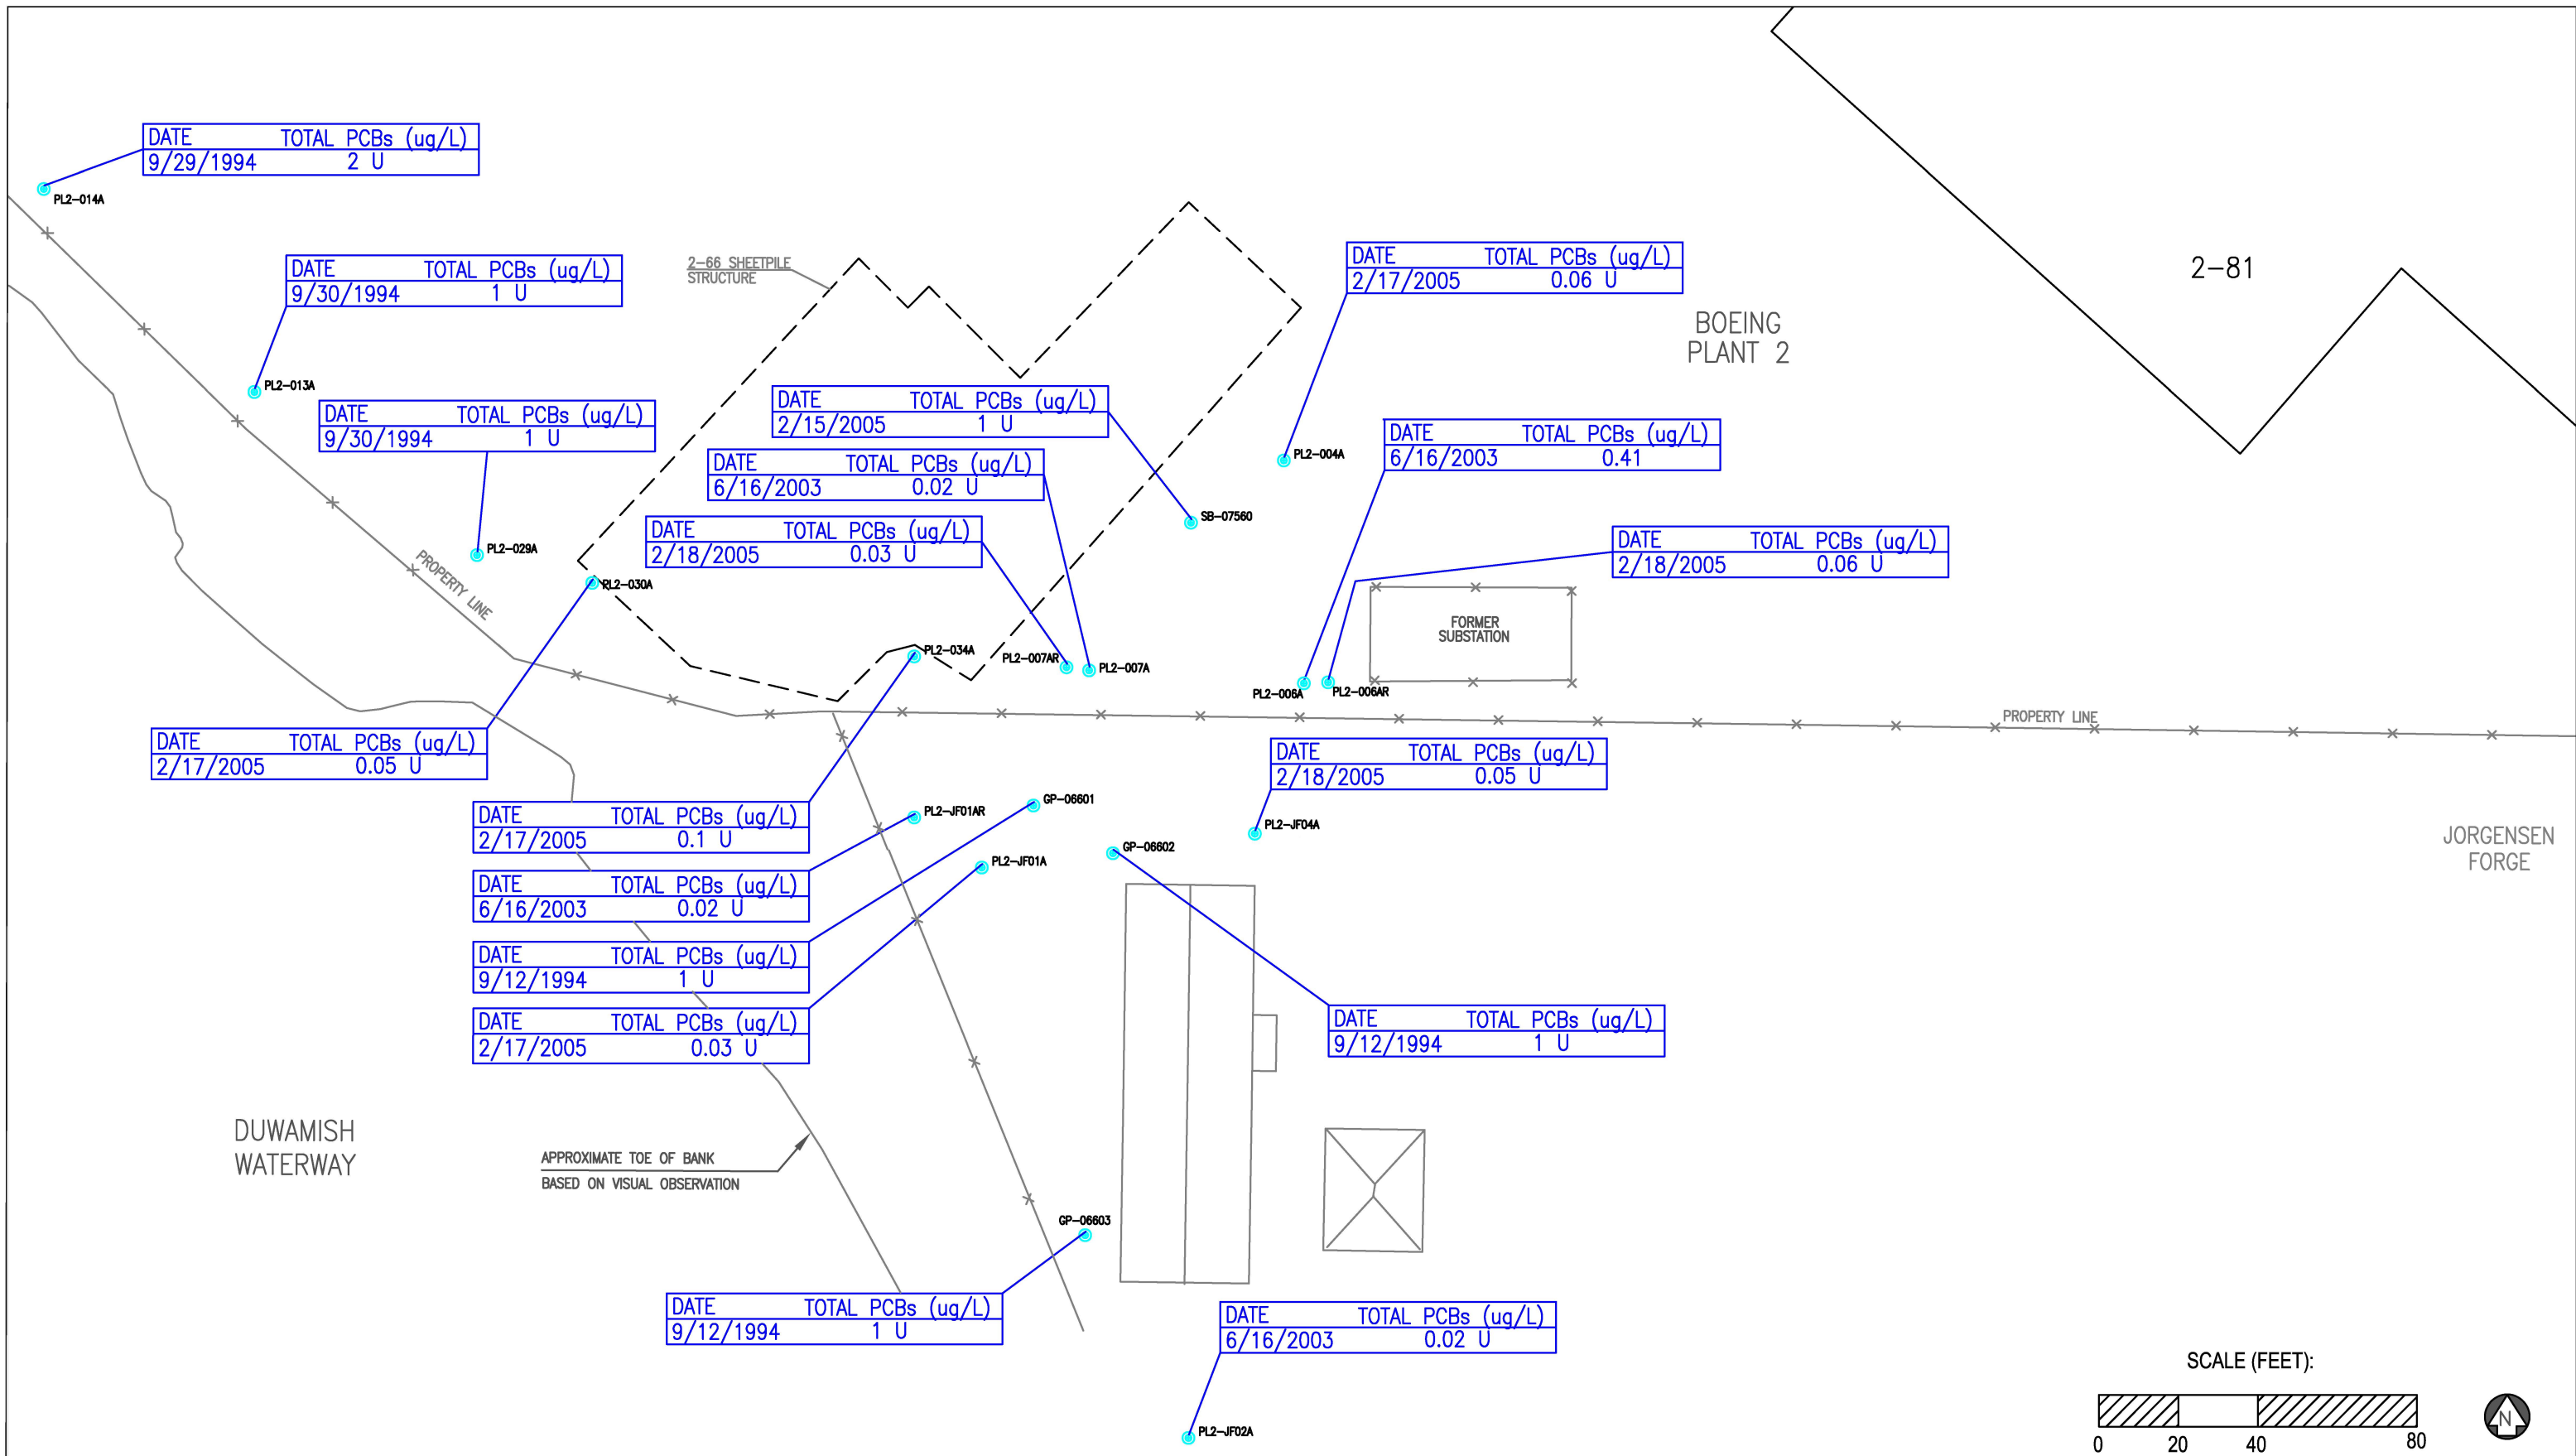
PHASE II TRANSFORMER PCB INVESTIGATION BOEING PLANT 2 SEATTLE, WASHINGTON				CHECKED		DATE		EXPLANATION OF DRAWING SYMBOLS - - - CHAIN LINK FENCE PL2-006AR WELL NAME 2/15/2005 SAMPLE DATE J VALUE IS AN ESTIMATE U NOT DETECTED ABOVE GIVEN DETECTION LIMIT ug/L MICROGRAMS PER LITER STATION WITH HISTORICAL PCB DATA IN GROUNDWATER				FIGURE 3.4 PHASE II AND PRIOR GROUNDWATER TOTAL PCBs ANALYTICAL RESULTS

Table 3.2 summarizes all of the Phase II analytical data for groundwater and Figure 3.4 presents the PCB analytical results. Older RFI sampling for adjacent wells not sampled as Phase I or II are also included on Figure 3.4. This figure indicates that since the RFI, PCBs were only detected in one well within the Transformer Investigation Area, the now-abandoned Well PL2-006A. The Phase II sample from the replacement Well PL2-006AR did not contain PCBs to a concentration of 60 parts per trillion (ppt). This indicates that the prior samples in PL2-006AR were biased by (1) high turbidity due to its improper construction, and (2) the well being screened across a soil zone with elevated PCB concentrations.

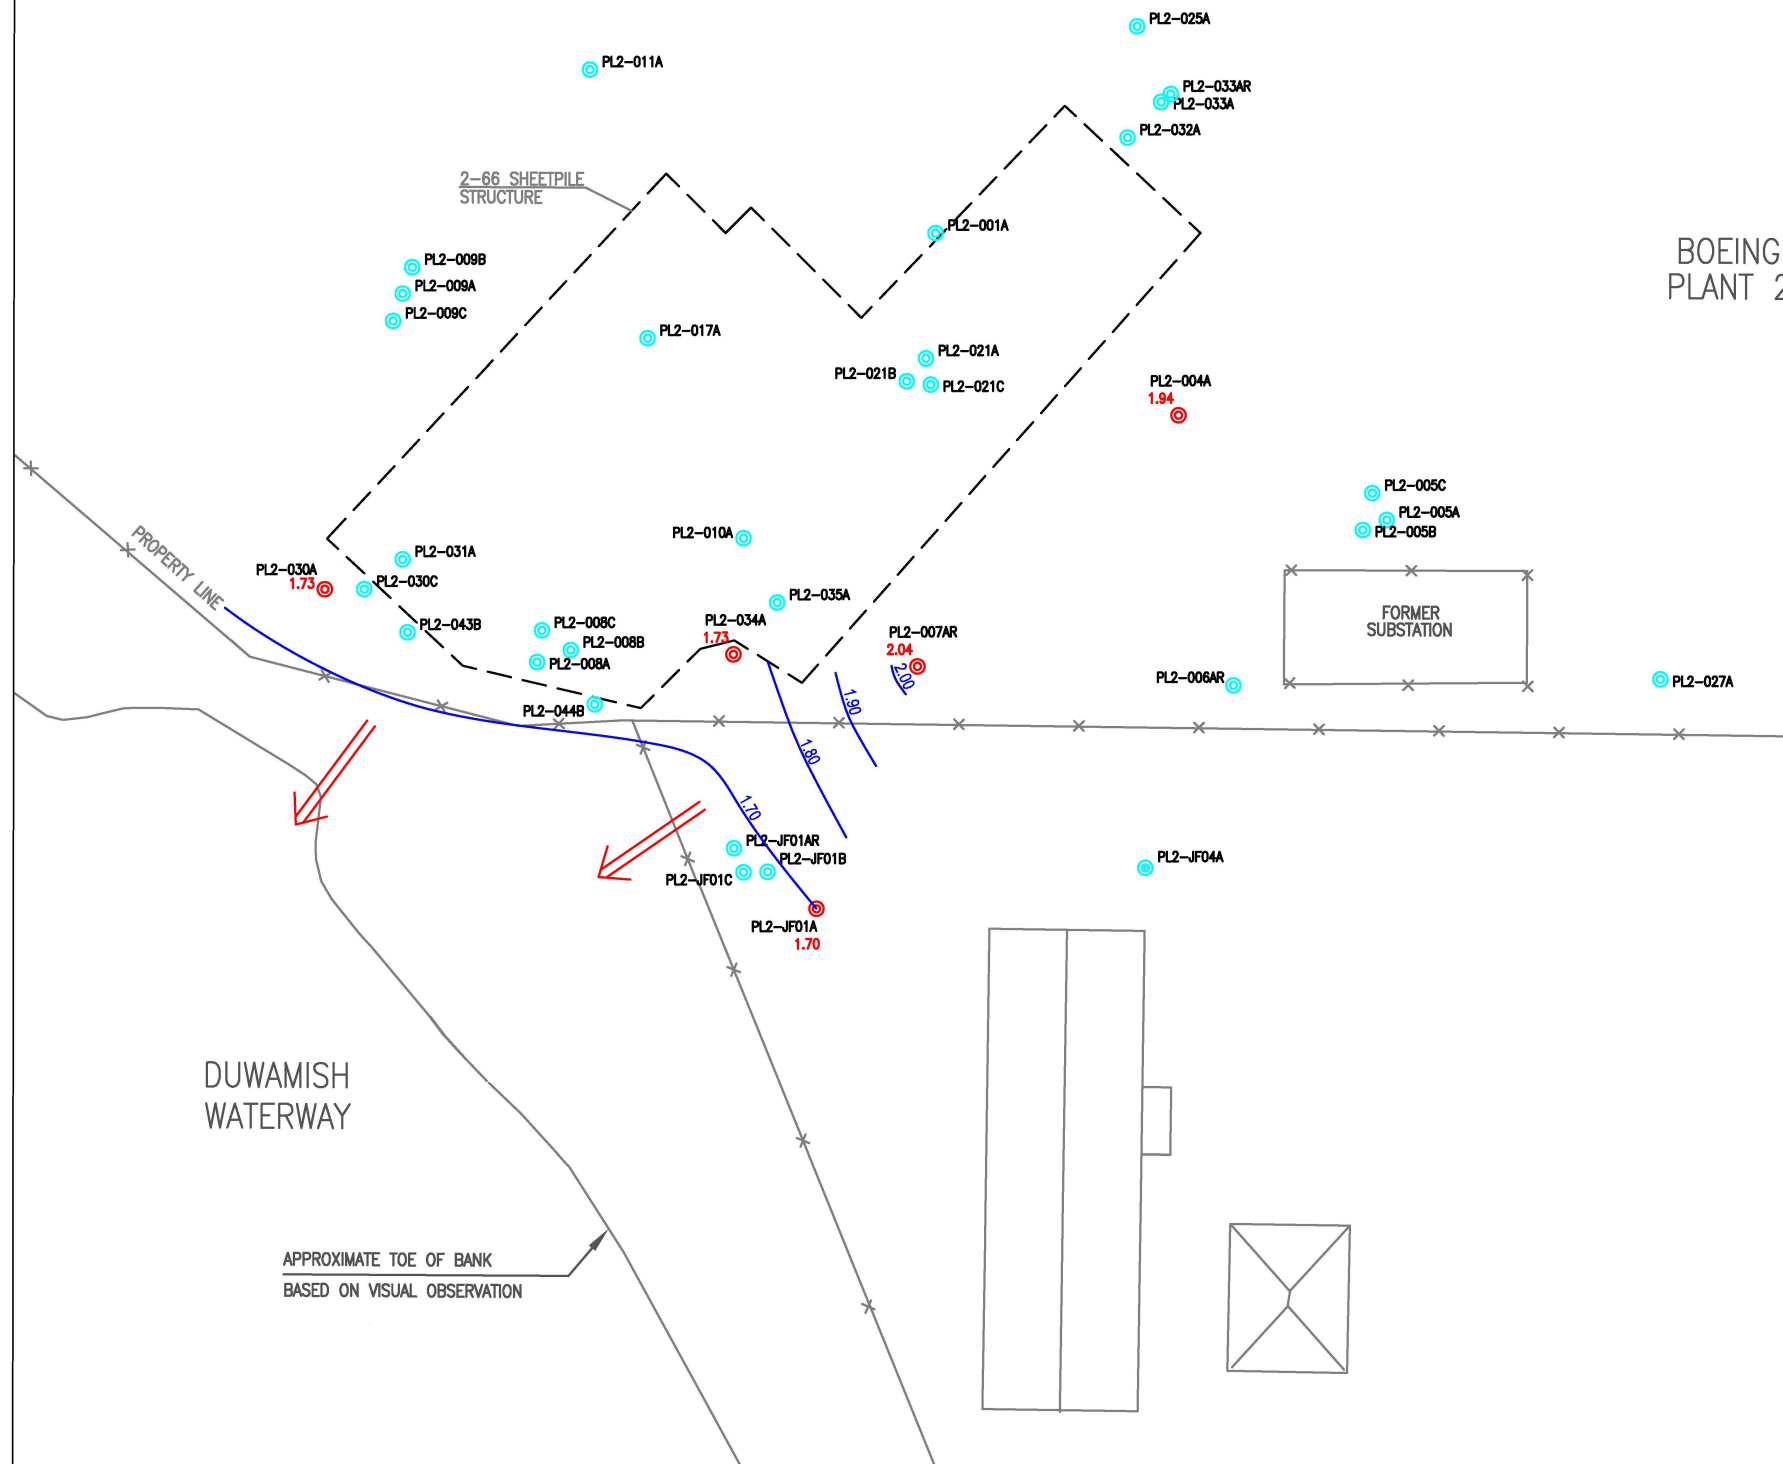
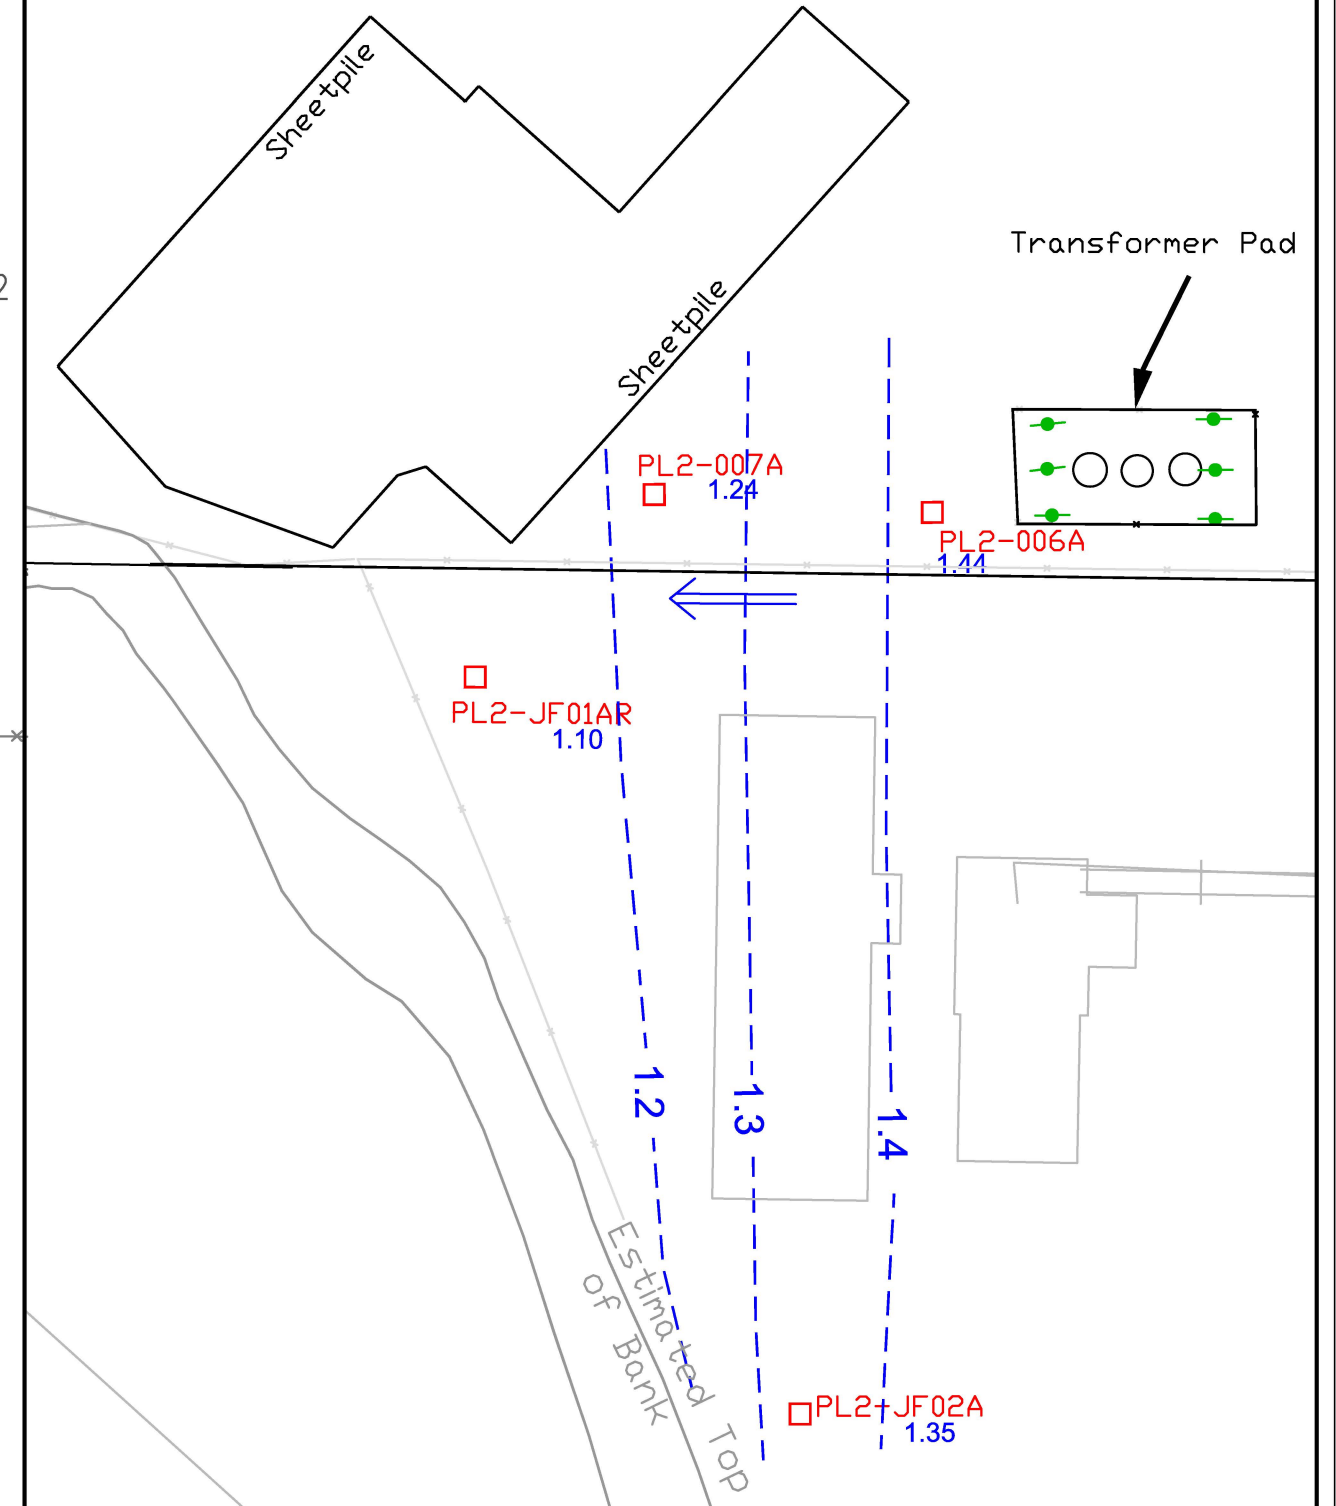
PHASE II 72-HOUR GROUNDWATER FLOW DIRECTION

- 1) PHASE I GROUNDWATER FLOW DIRECTION IS BASED ON 72-HOUR MEAN GROUNDWATER ELEVATIONS COLLECTED DURING A TRANSDUCER STUDY PERFORMED JUNE 2003 (FSM 2004).
- 2) PHASE II GROUNDWATER FLOW DIRECTION IS BASED ON 72-HOUR MEAN GROUNDWATER ELEVATIONS COLLECTED DURING A TRANSDUCER STUDY PERFORMED 14 THROUGH 18 MARCH 2005.

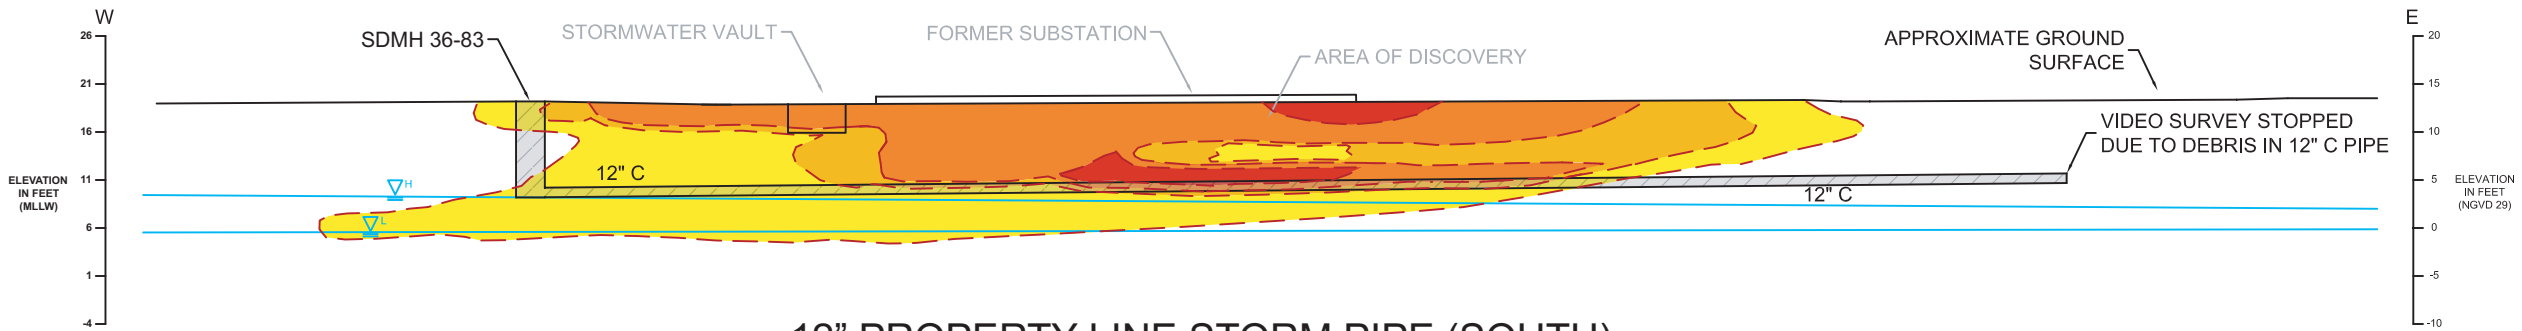
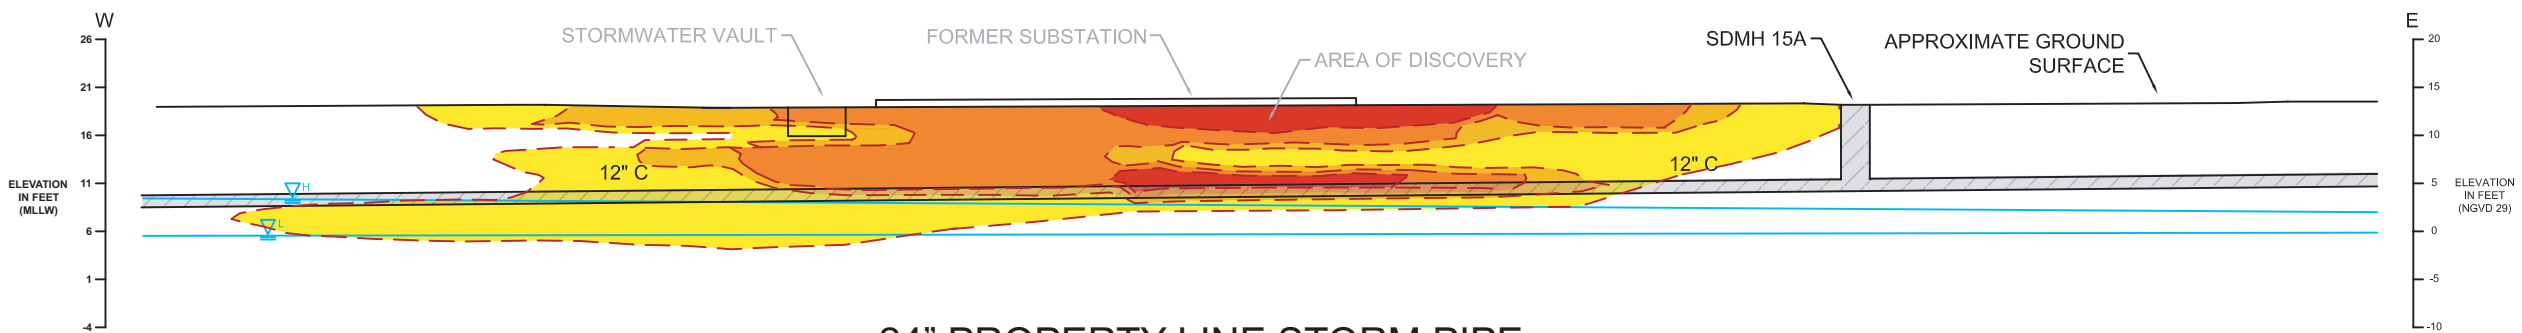
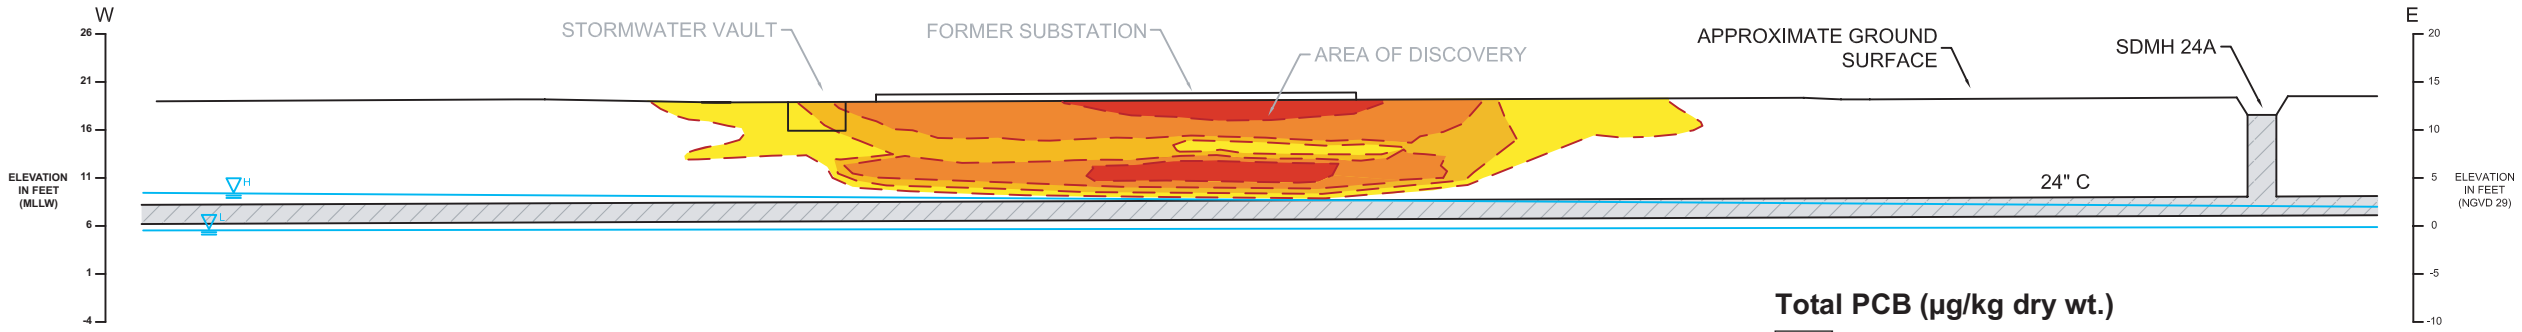
12" BOEING STORM PIPE (NORTH)

12" PROPERTY LINE STORM PIPE (SOUTH)

24" PROPERTY LINE STORM PIPE

- NOTES:
- GROUNDWATER ELEVATIONS SHOWN WERE INTERPRETED FROM MEASUREMENTS MADE DURING A 72-HOUR TRANSDUCER STUDY PERFORMED 14 THROUGH 18 MARCH 2005.
 - STORM PIPES WERE INVESTIGATED USING A VIDEO CAMERA OR SNAKE/SONDE EQUIPMENT. INVESTIGATION CONDUCTED BY WESTON IN FEBRUARY AND MAY 2005.
 - THE STORMWATER VAULT, FORMER SUBSTATION, AND AREA OF DISCOVERY ARE PROJECTED ONTO EACH PROFILE FOR REFERENCE ONLY.
 - PCB DISTRIBUTION BASED ON FIGURE 3.3.

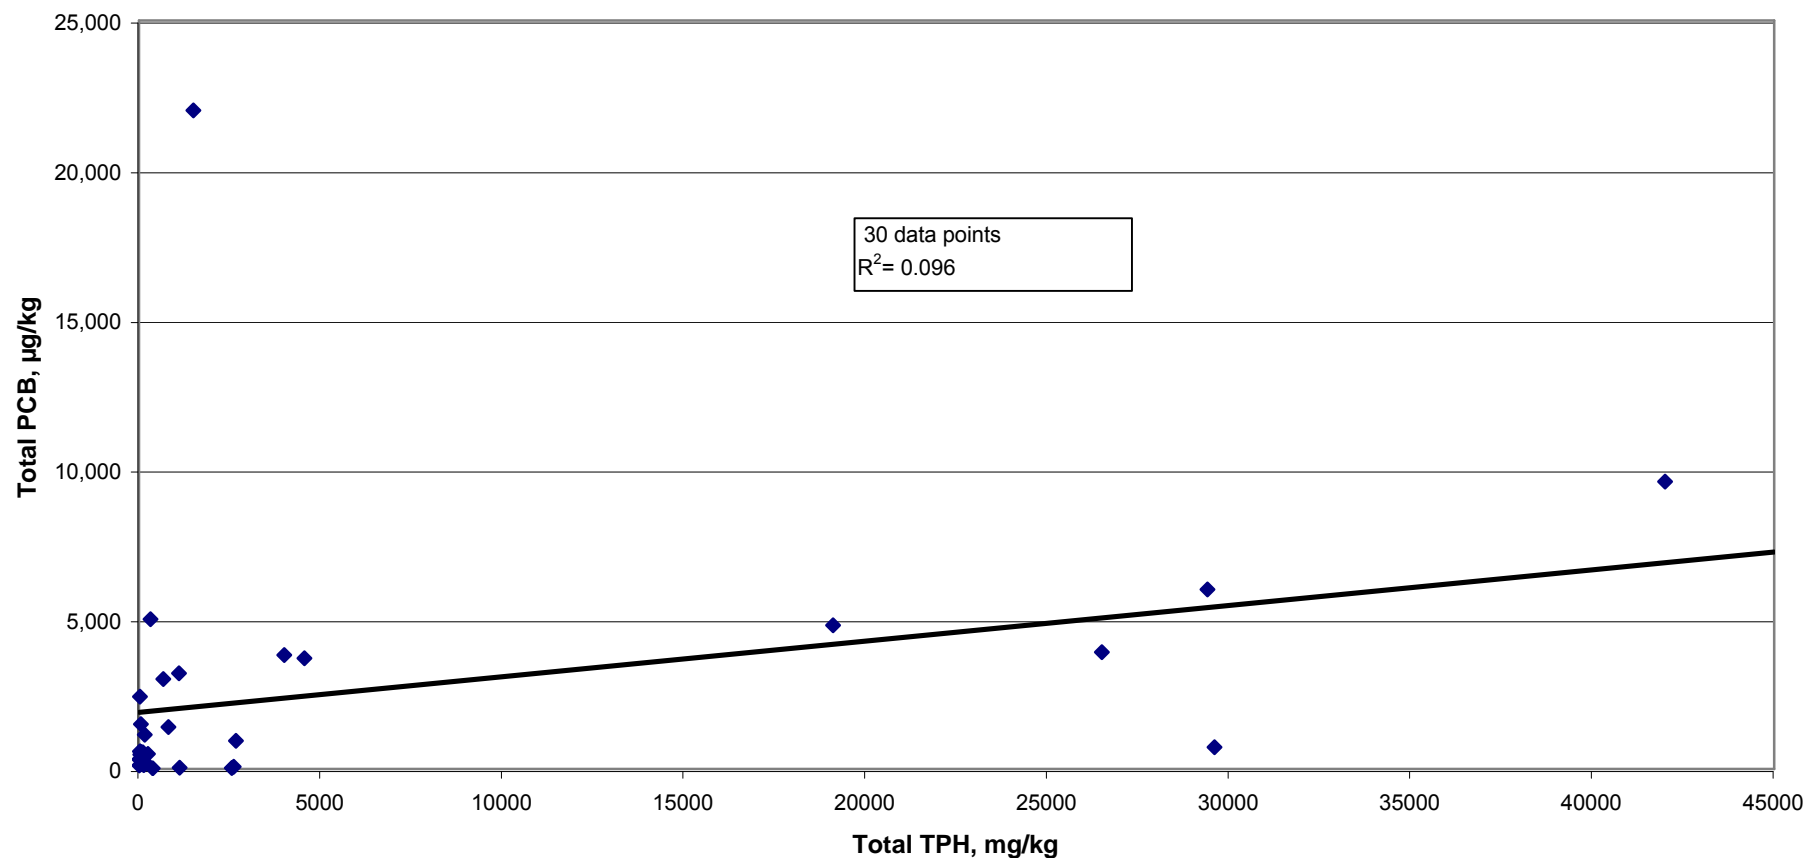
Total PCB Concentration vs. Total TPH Concentration—Includes Phase I and II Data

1. Data are plotted for samples with detected PCB concentrations that were also analyzed for TPH.
2. Total TPH is the sum of any and all fractions analyzed.

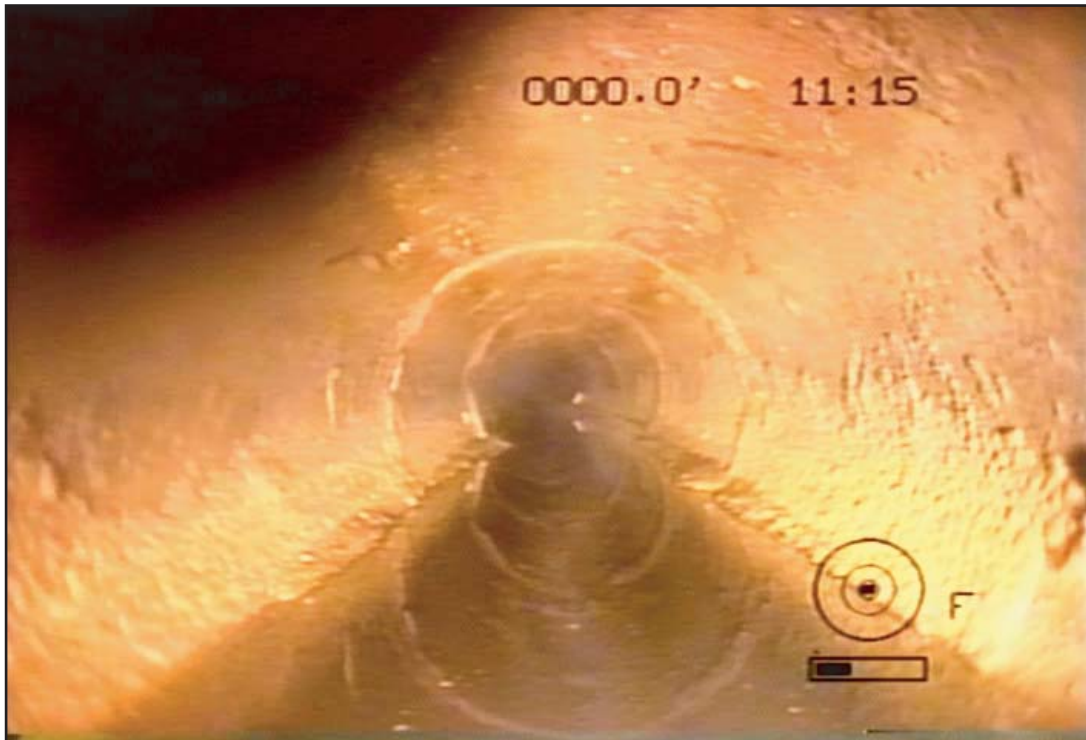
photo 1

View from SDMH 36-83 facing east in 12-inch concrete Boeing storm pipe.

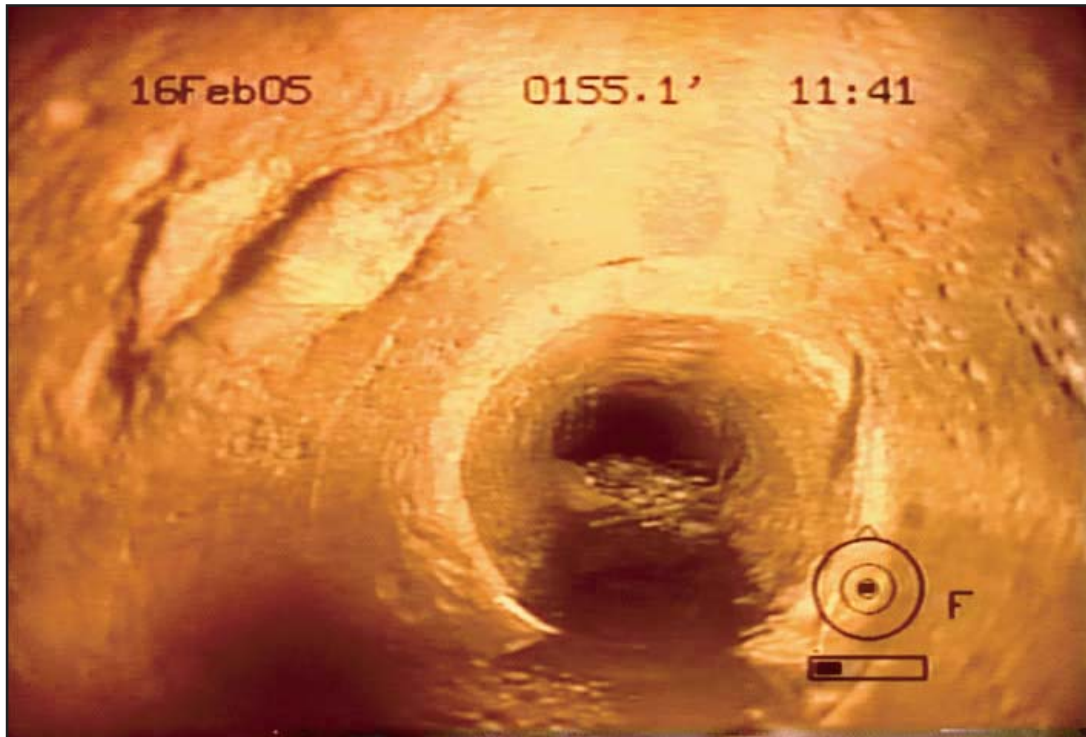
photo 2

End of video survey on 12-inch concrete Boeing storm pipe due to debris in pipe, view facing east; also visible is a 6-inch lateral pipe connection.

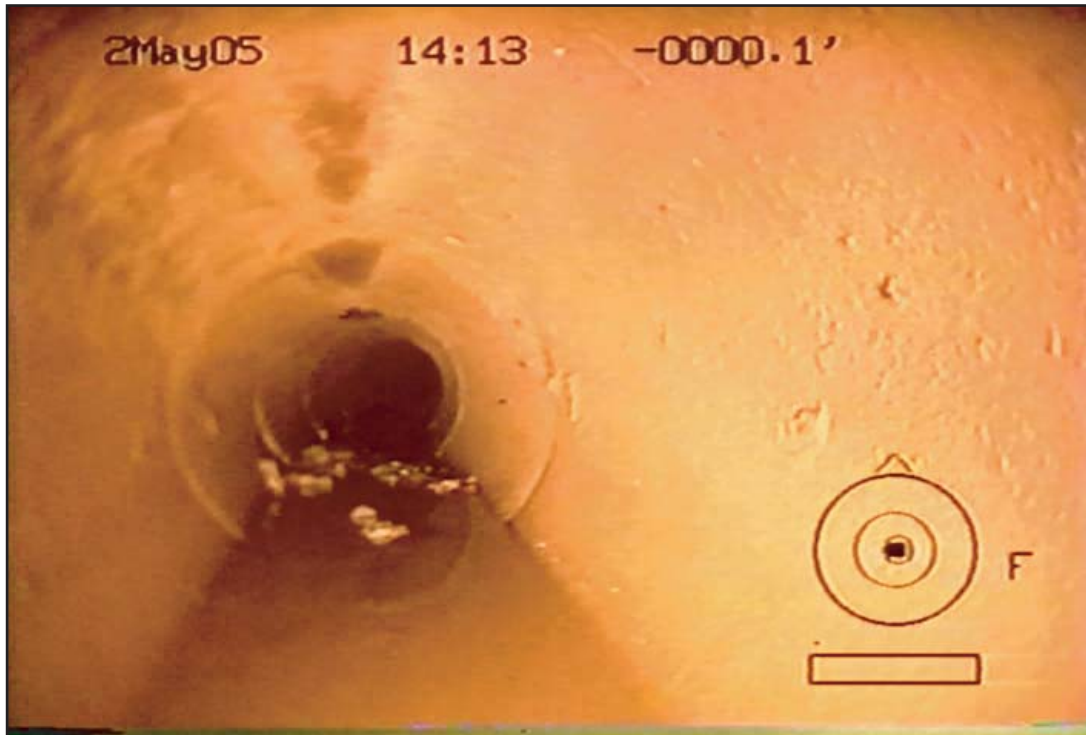
photo 3

View from SDMH 15A facing west in 12-inch concrete Property Line storm pipe.
